NBSIR 76-1025

Air-Mobility Rigid Shelter Systems

November 1975

An Interim Report

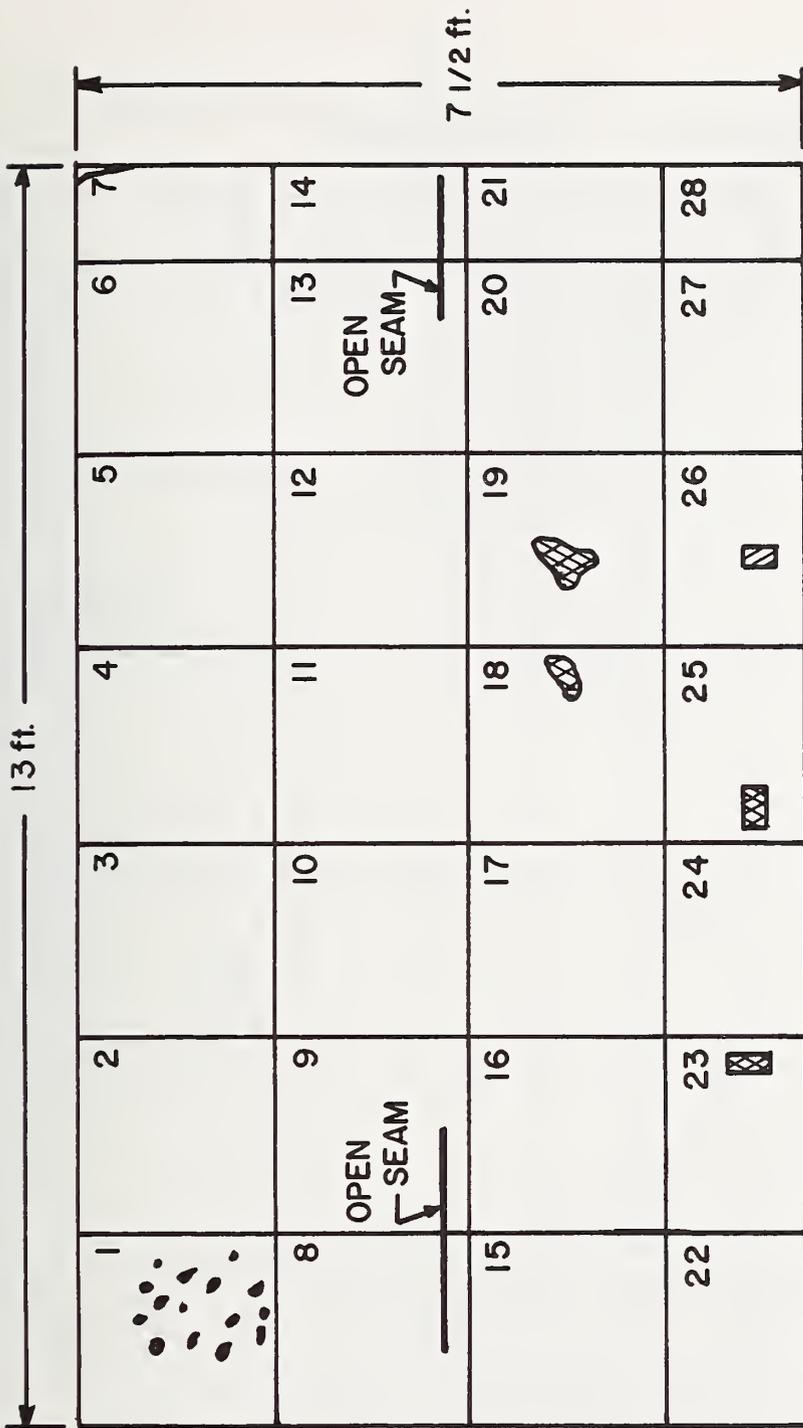
Fig. 3.11 Indentations and damaged areas on exterior of EXP Panel 14 L

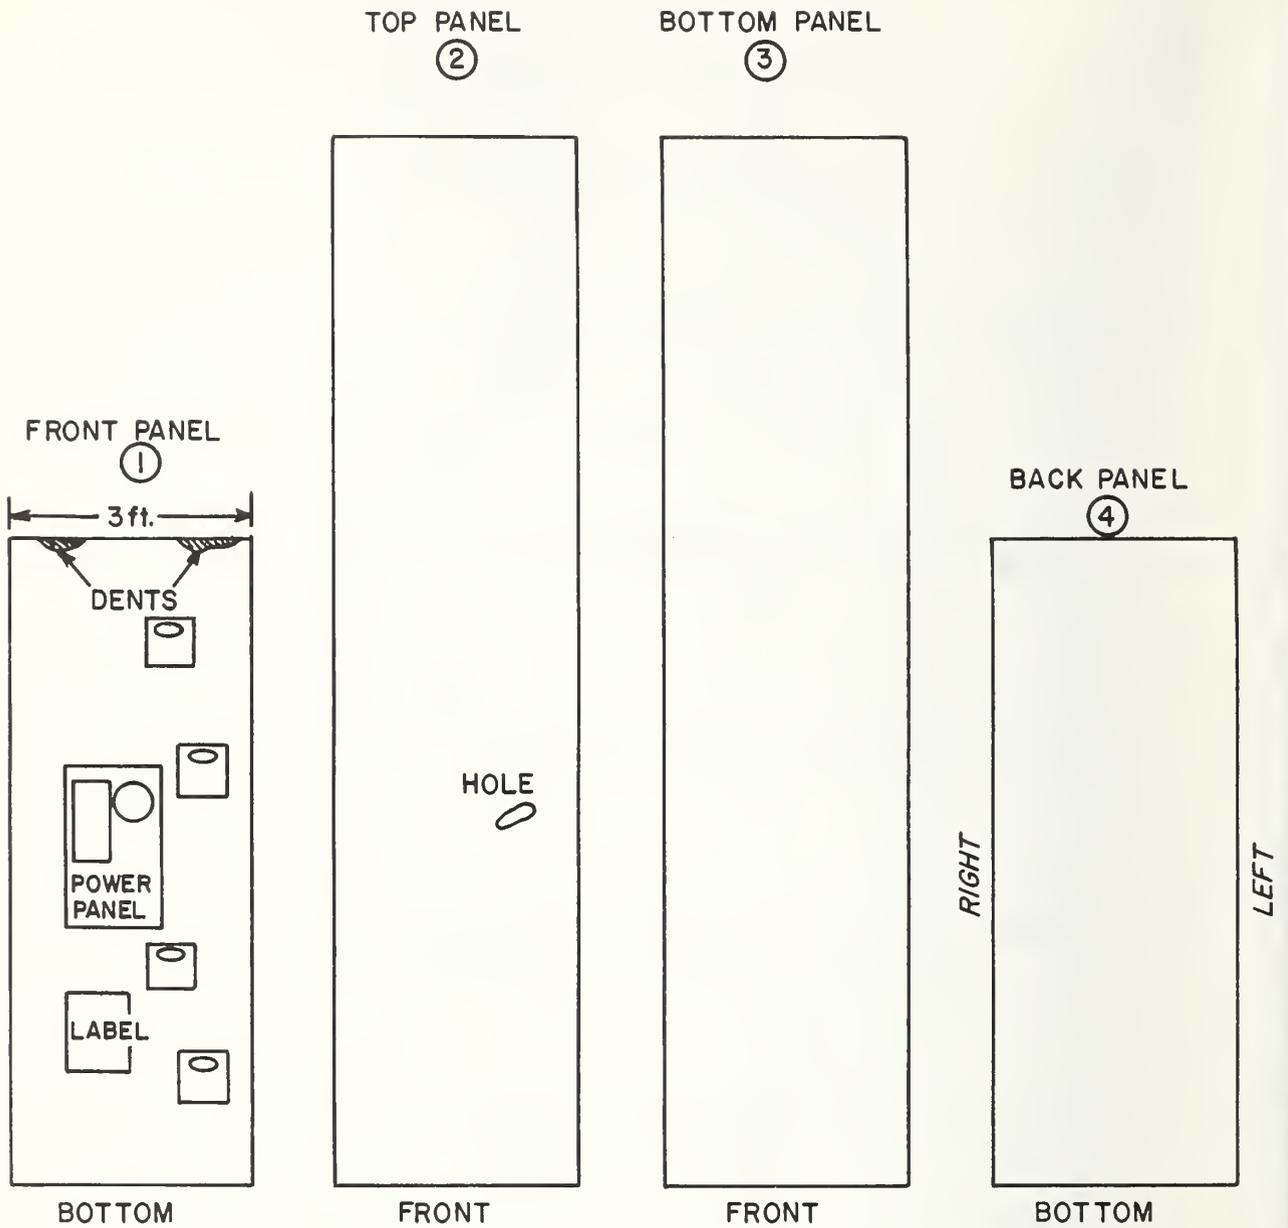
Fig. 3.12 Indentations and damaged areas on exterior of EXP center-structure panels

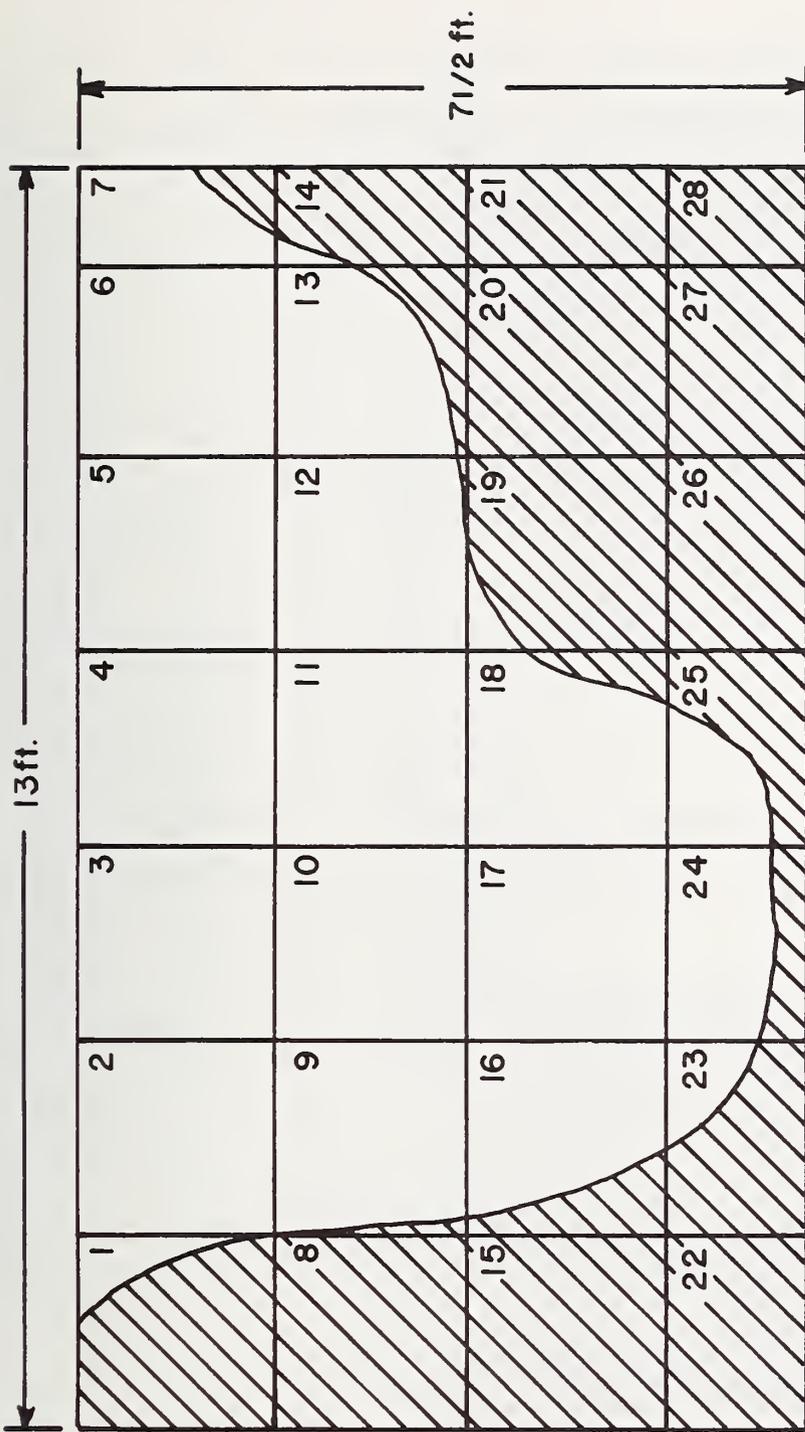
Water was also found in the core of panel 14R, when squares were cut from it. In fact, squares 20, 26, and 27 were completely filled.

Fig. 3.13 Location of water found in core of EXP Panel 14 R

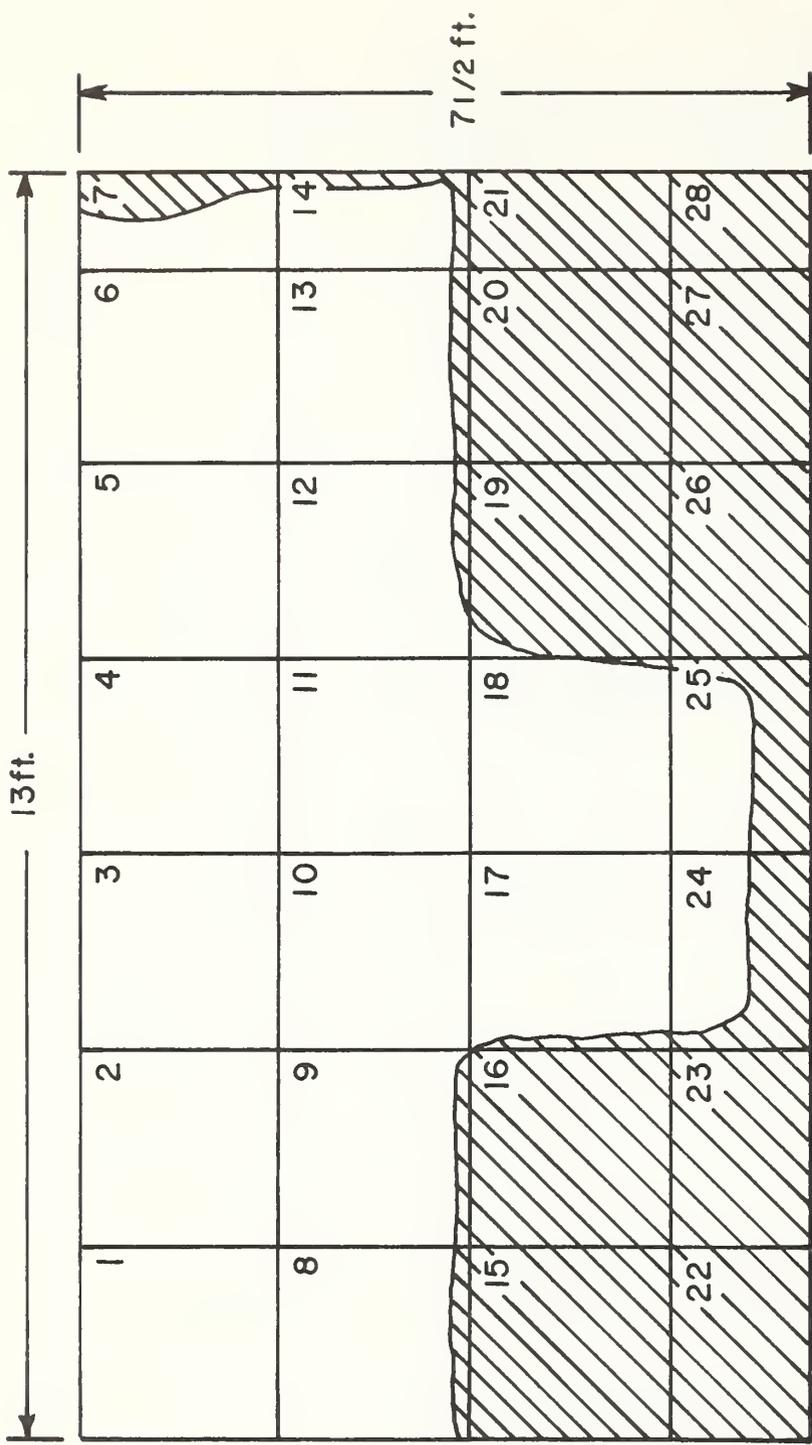
Fig. 3.14 Location of water found in core of EXP Panel 14 L

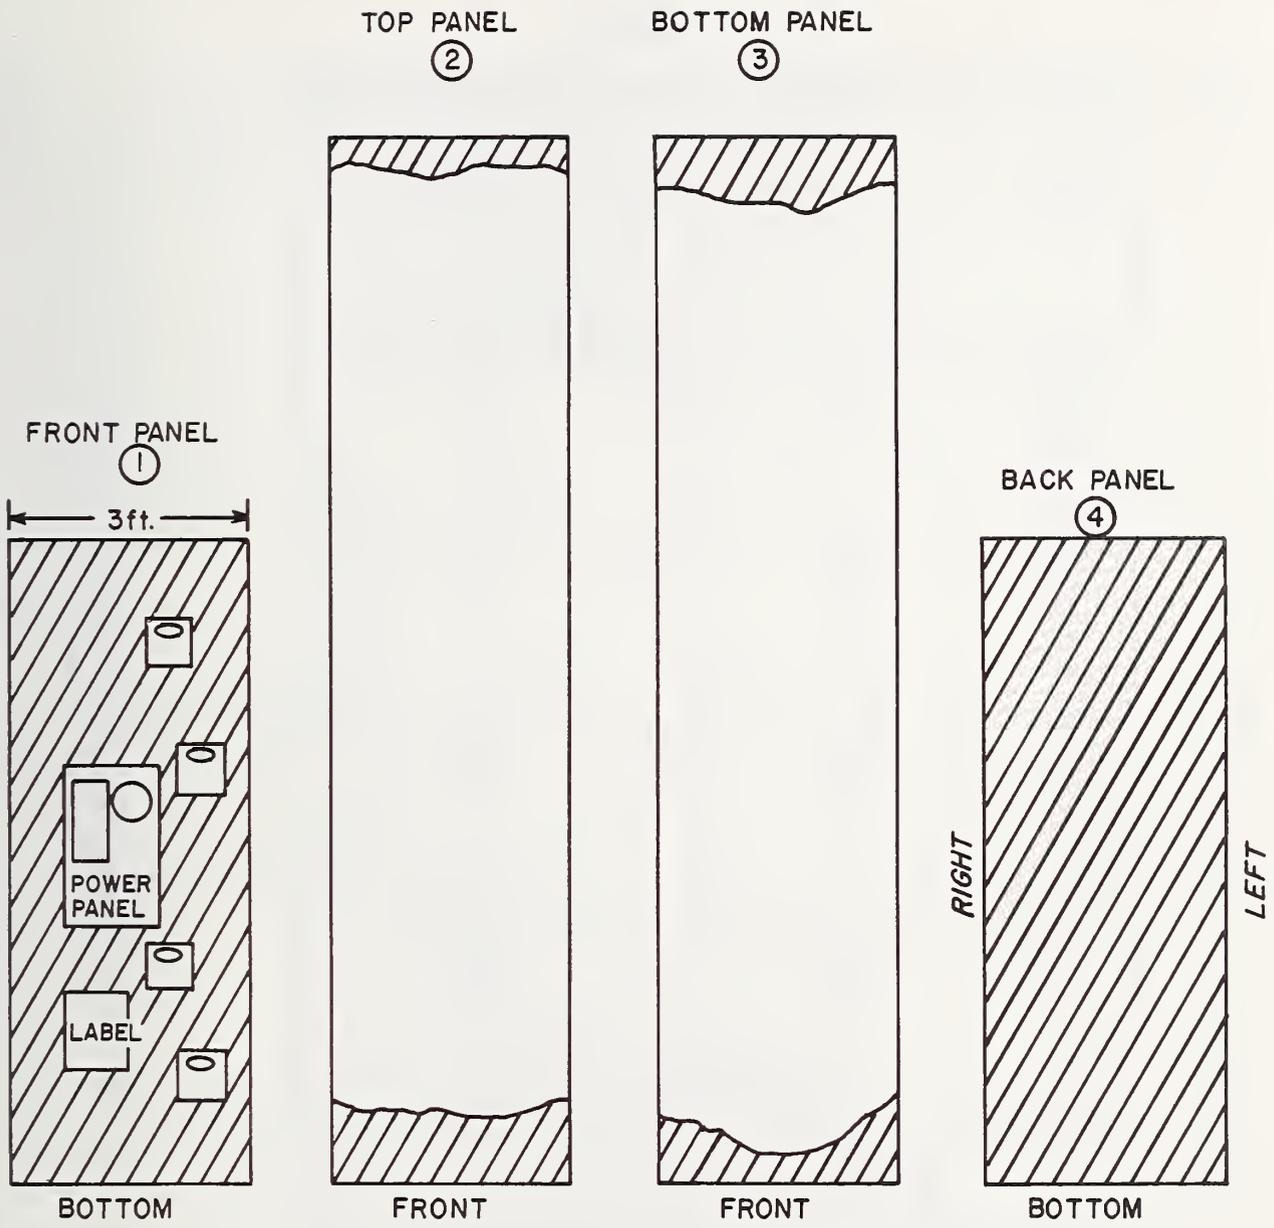
Fig. 3.15 Location of water found in core of EXP center-structure panels

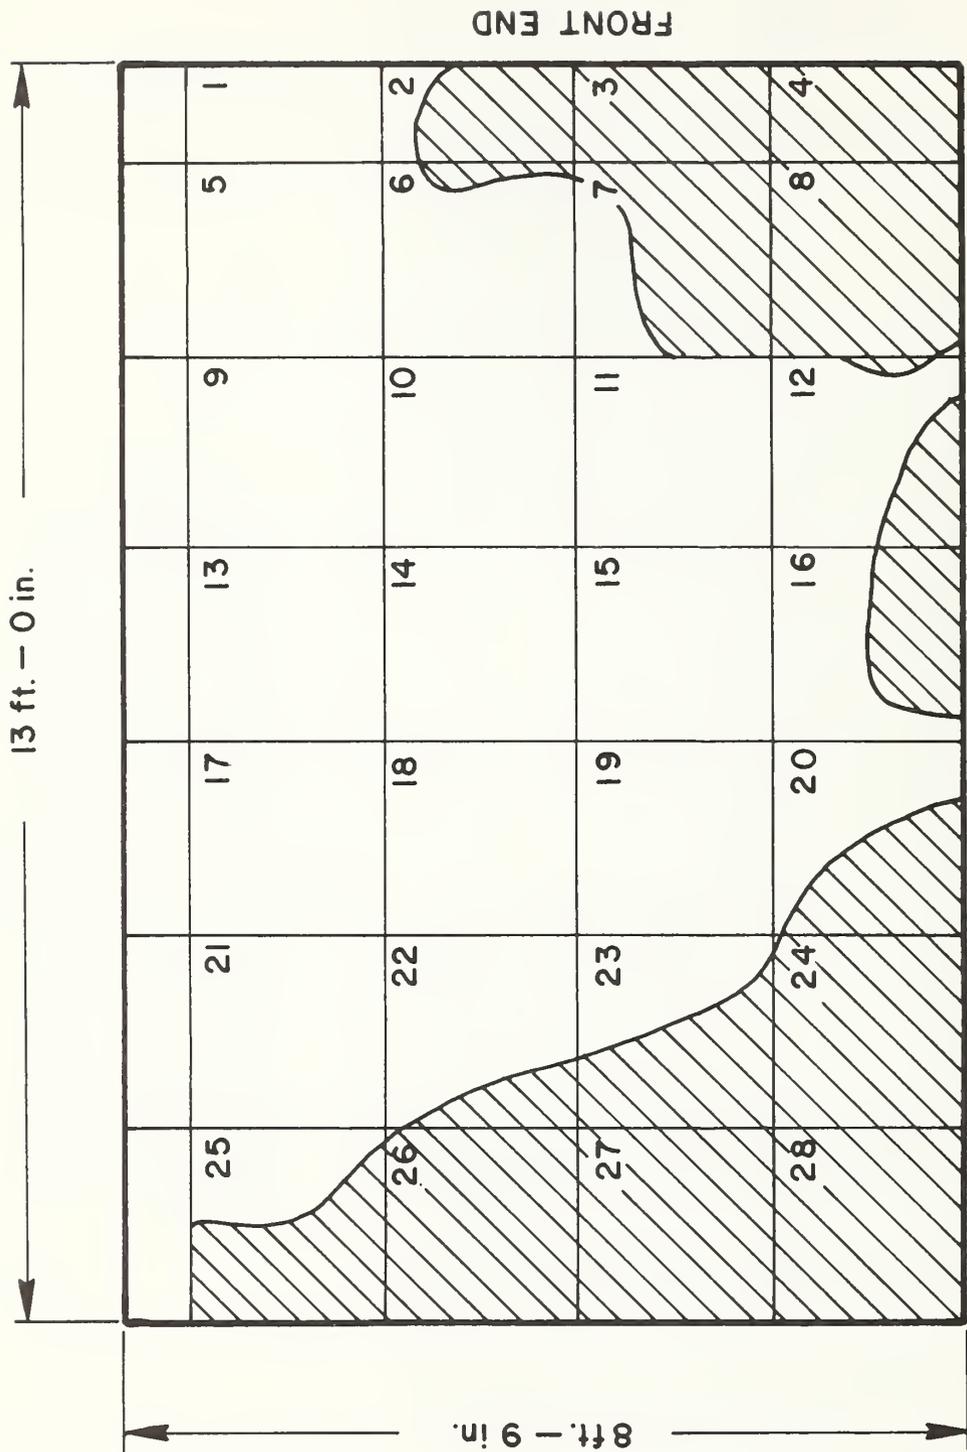
Fig. 3.16 Delaminations of interior facing on ES/C Panel 3 (Fixed floor panel)

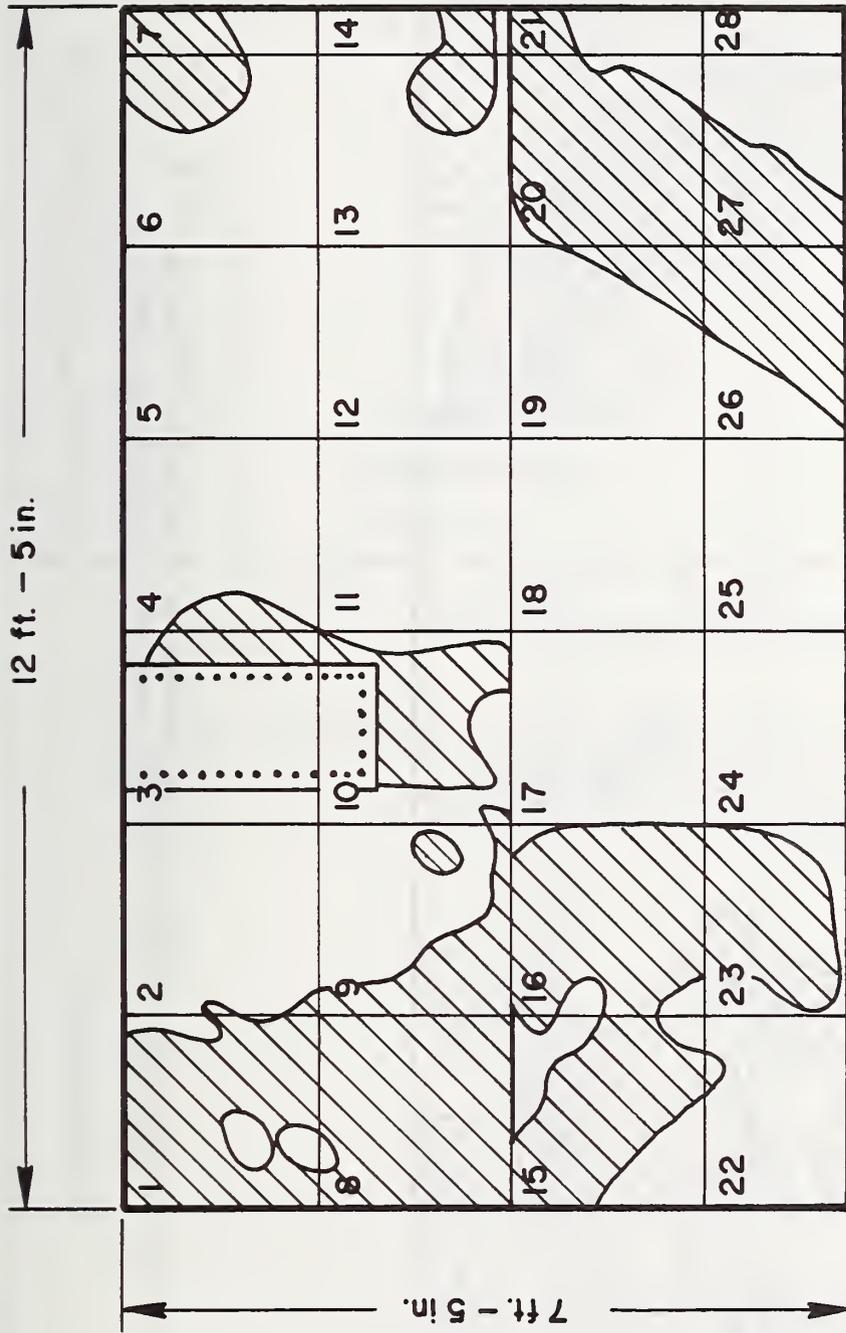
Fig. 3.17 Delaminations of exterior facing on ES/C Panel 5 R (Fold-down floor panel)

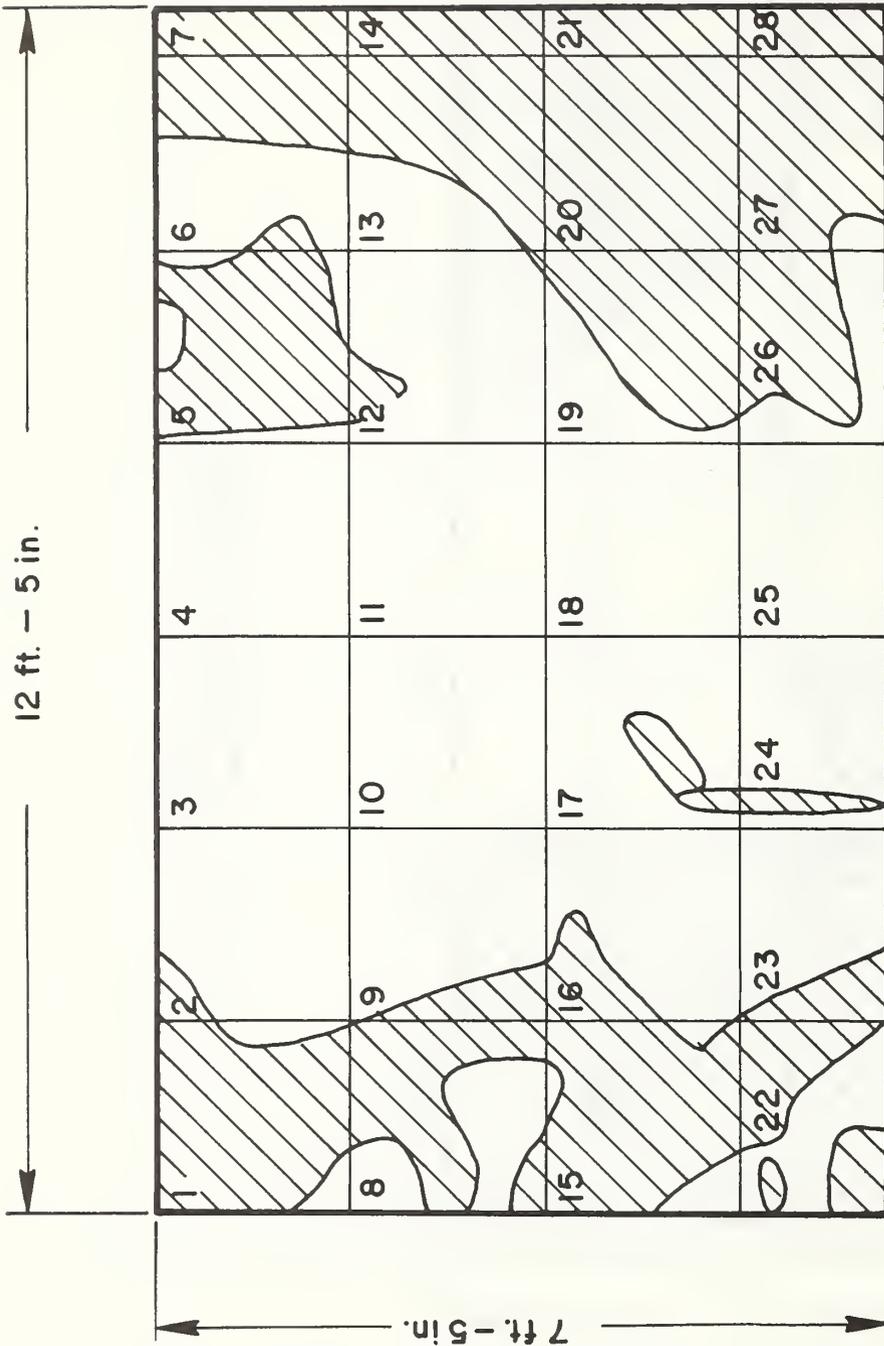
Fig. 3.18 Delaminations of exterior facing on ES/C Panel 6 L (Fold-up roof panel)

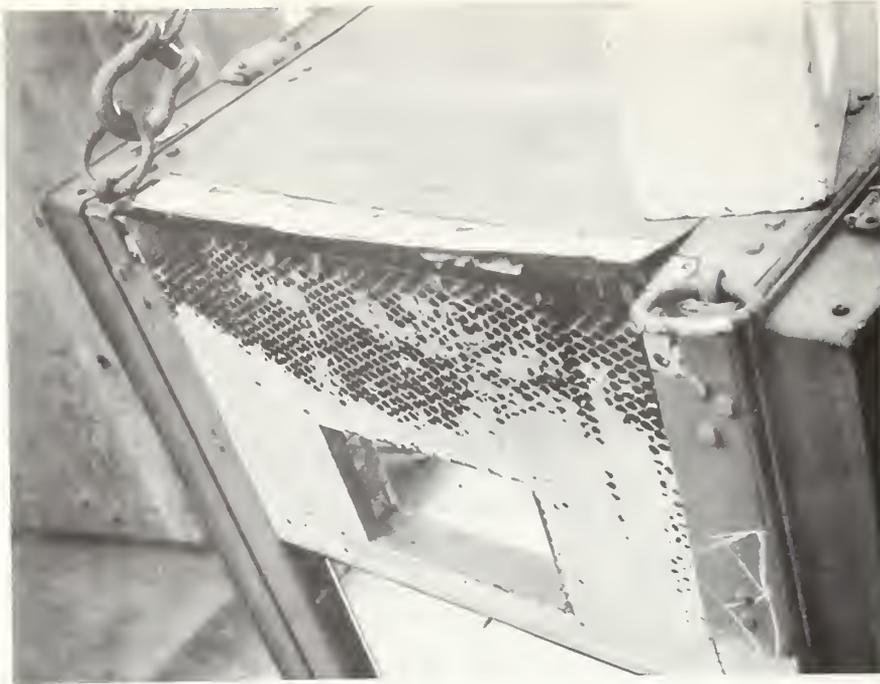
Fig. 3.22 Water-entry point on upper corner of EXP center structure (Aluminum corner seal removed)

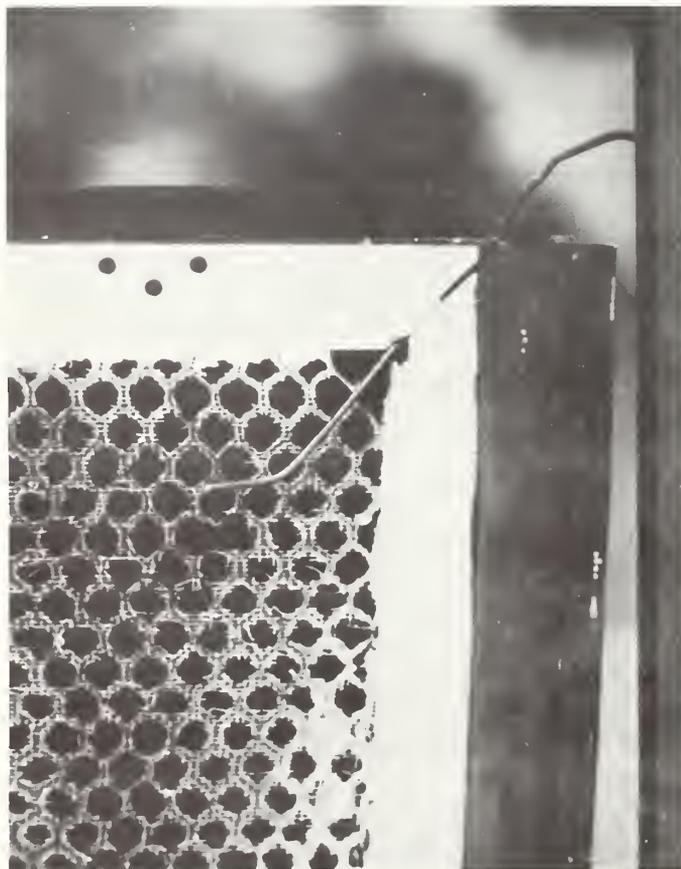
Fig. 3.23 Water entry point on upper corner of EXP Panel 14 L (Fold-down floor panel)
